WMV bv.
Lunac 2+ duplo
NBD 10300 (2010) Qualification Test

Client: WMV bv.
Contact: Mr. G. van der Sluis
Date: September 26, 2011
Author: Guus Coolegem
Reference: CCubeR11-09211
Status: Final

Lunac 2+ duplo NBD 10300 (2010) Qualification Test

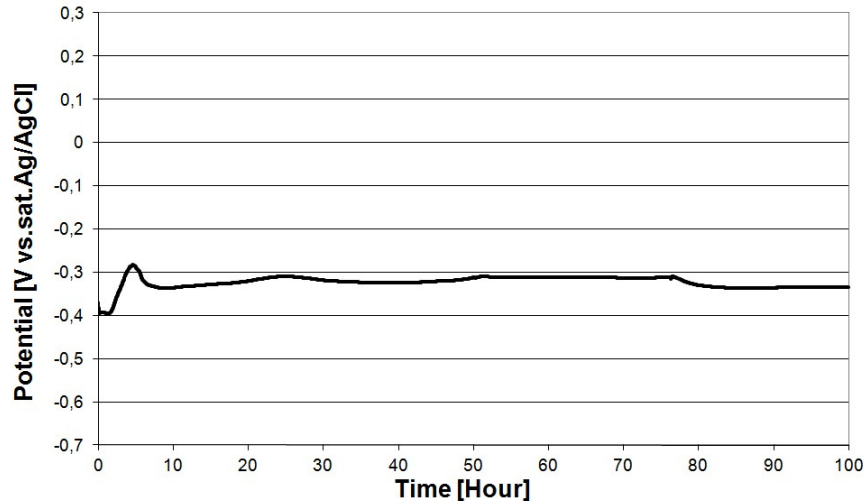
For the test sample, the potential has been measured in 3.4% NaCl solution for 100 hours from the start of the test, see Figure 1.

Figure 1: Potential measurement of the Lunac 2+ coating, for 100 hours.

The potential after 100 hours immersion is -0.33V. After this test a polarization curve has been measured, see Figure 2.

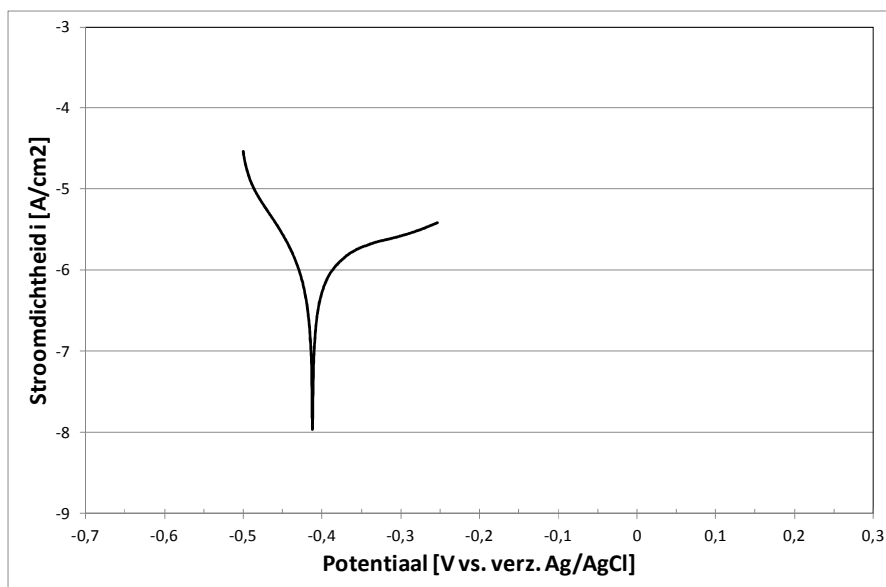
Figure 2: Polarization curve of the Lunac 2+ coating, at 0.5mV/s.

Interestingly, the potential of the polarization curve is equal to the potential at the start of the potential measurements. This indicates that the oxide layer which has built up in 100 hours during the negative polarization in the first part of the polarization curve (left of the V-shape) breaks down locally.

With the polarization resistance, and Table Modelling Slope of the curve (ISO 17475), the corrosion current density can be derived, at a level of $0.5 I_{corr} \mu\text{A}/\text{cm}^2$, with a corrosion rate of 1-4 μm per year. The repassifying potential I_{repass} could not be determined as a result of the uniform corrosion mechanism.

Based on the polarization curve, the current density for the test is determined for the galvanostatic exposure $galvstat = 5\mu\text{A}/\text{cm}^2$. For more than 1000 hours, 1400 hours this current is observed, see Figure 3.

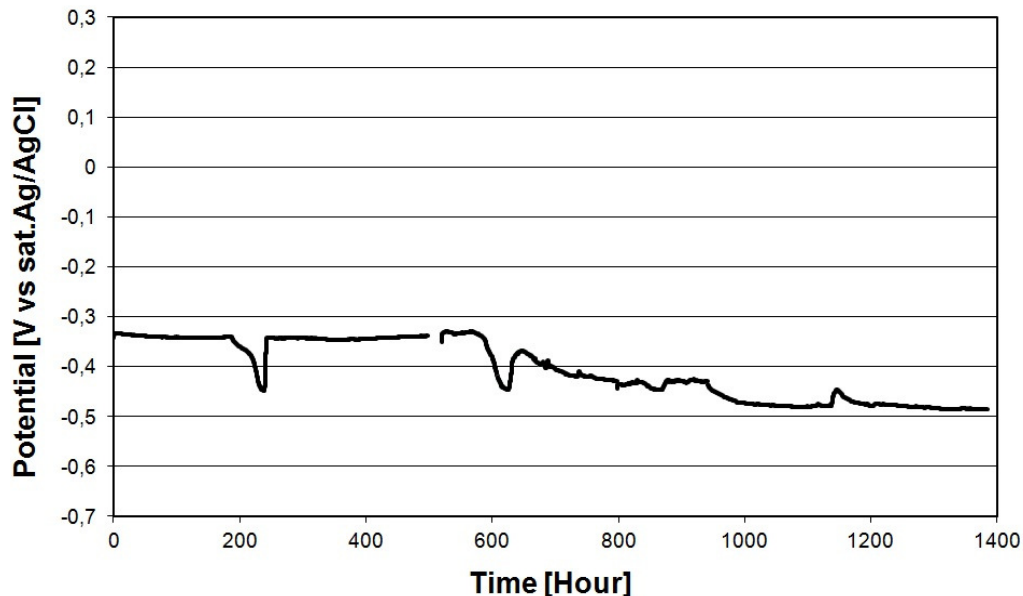
Figure 3: Galvanostatic test, during 1400 uur at $5\mu\text{A}/\text{cm}^2$.

From the shape of the graph of the galvanostatic test it can be determined that the coating activates during the test. After the test, the measured potential is: -0.34 V vs. sat. Ag/AgCl. Since this is very stable, the chart has not been included in this report. After the potential measurement of 100 hours a polarization curve has been measured, see Figure 4.

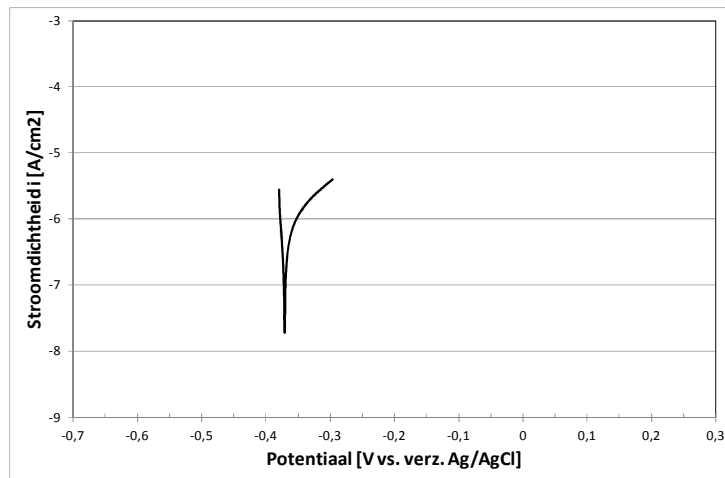
Figure 4: Polarizationcurve after the galvanostatic test.

The potential in the polarization curve is -0.36 V, slightly lower than the potential measurement. The corrosion current density in the curve is 0.6 $\mu\text{A}/\text{cm}^2$, the corrosion rate is almost equal to the corrosion rate for the test, 1.5 to 4.5 $\mu\text{m} / \text{year}$. The corrosion mechanism is uniform corrosion, which can be seen at the positive right branch. Photographs of the surface are given in Figure 5.

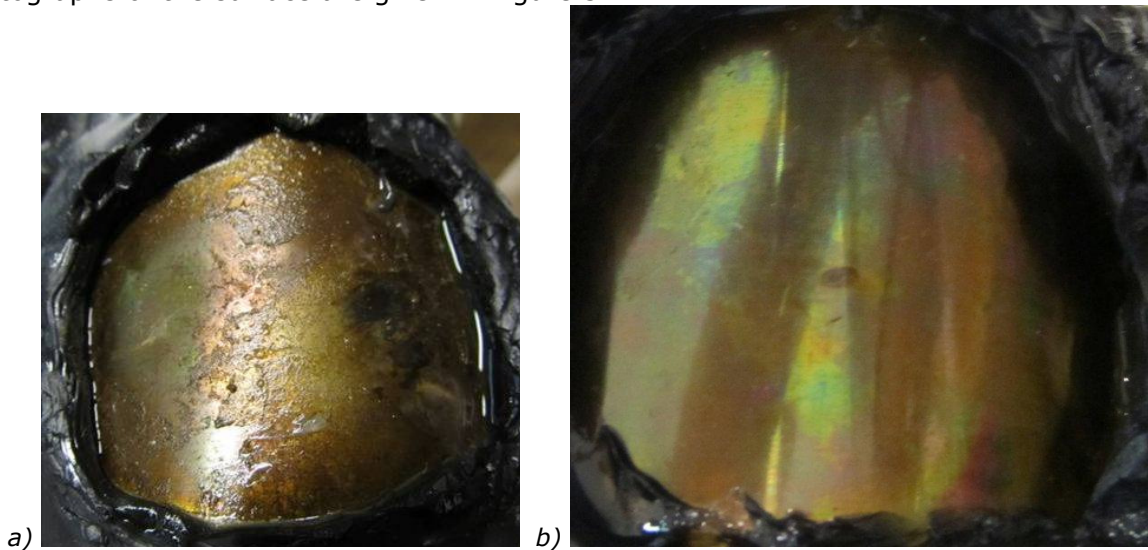
Figure 5: The surface after testing, before (a) and after 9b) removing the corrosion product with a cloth.

The surface looks stable, in the middle of the surface a small area is present with a different color. There is no visually observable damage to the surface, even in the middle area.

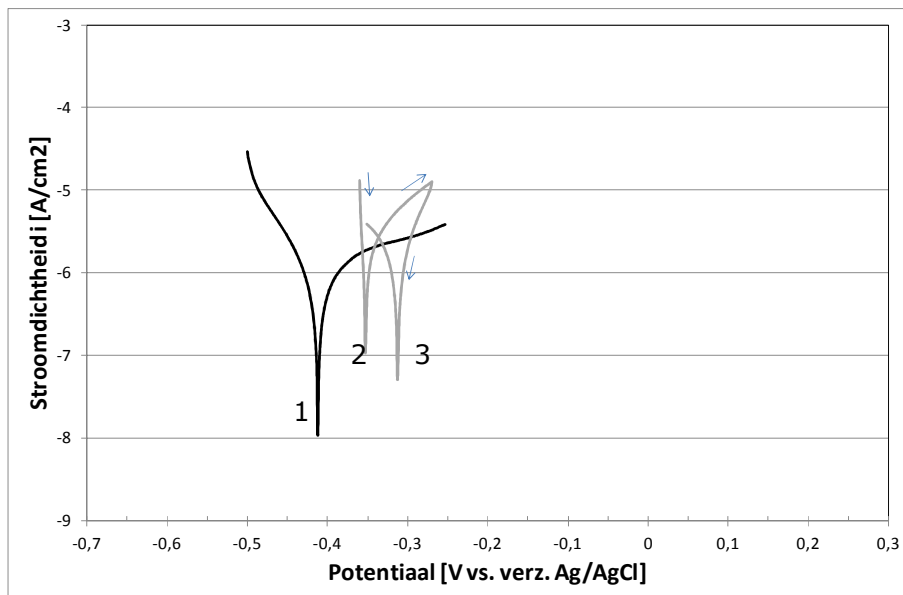
During positive polarization, the corrosion rate first increases and then decreases again because a new thicker oxide layer builds up. This can be visualized by recording consecutive polarization curves, see Figure 6.

Figure 6: Consecutive polarization curves, where the corrosion rate is proportional to the height of the V-shape in the graph. The second curve, taken immediately after the first, is higher, and at the retreating measurement the V-shape is at a lower level (= proportional to corrosion rate).
